# R115 Armagh Street - Bridge Status Summary Report

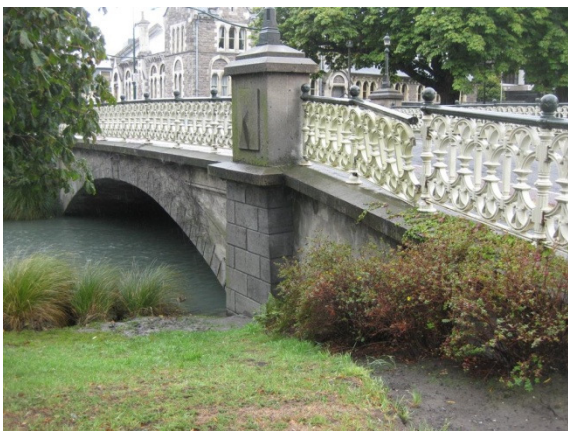
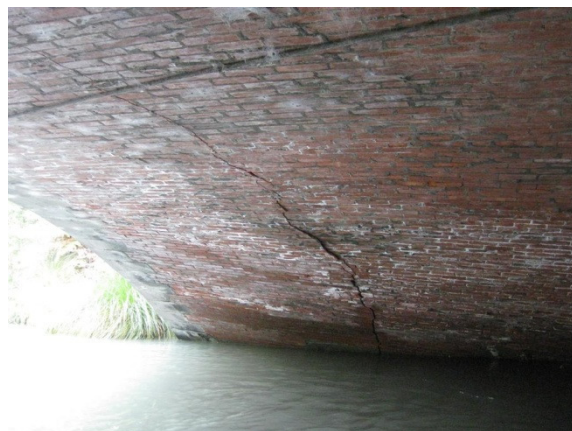
The bridge suffered significant damage in the February 2011 earthquake. In particular, pavement damage was observed on the approaches and at midspan of the arch; a 20mm wide longitudinal crack (slightly skewed to the road centreline) was observed over  $\frac{3}{4}$  of the length of the arch; and vertical cracks were observed in the spandrel walls. For a more comprehensive discussion of the damage observed, refer to Work Package Concept Report WP0000467.

The live load capacity of the masonry arch is not considered to have significantly altered as a result of the EQ damage, with loads still being supported by arch action either side of the longitudinal crack. The structure’s ability to distribute point loads across the crack at the apex of the arch may be compromised slightly; however the crack is smaller at this location and any damage would be localised, progressive and observable through ongoing monitoring.

The arch is prone to further cracking from seismic loading due to the skew of the structure and if settlement and lateral spreading occur in future sizeable aftershocks; however, this is not expected to present a sudden collapse scenario.

As the bridge is currently not in use, no crack monitoring is being undertaken at present. However, the arch crack has been measured at 20mm at its widest point. This should be checked following any significant aftershocks (i.e. Mag>5.5).

To reduce impact loading and protect the arch from further damage, a 30km/h heavy vehicle speed restriction has been implemented. We recommend formalising this through gazetting in local newspapers, in accordance with the Heavy Motor Vehicle Regulations. The bridge is currently closed due to its location within the “red zone”. When the bridge is reopened, the southern lane could remain closed to protect the structure from further damage. Some temporary surfacing repairs should be undertaken prior to opening the structure to traffic. The serviceability of the tram rails over the arch is unknown at this stage.

Permanent recovery works are being progressed through the SCIRT Alliance and continued inspection and monitoring should be undertaken following significant aftershocks (i.e. Mag>5.5).
